CASE STUDIES

Case Study: Assessing Surface Vehicle Traffic Vibrations in Lima, Peru

Location 1 - Station E-26

Location 2 - Station E-27

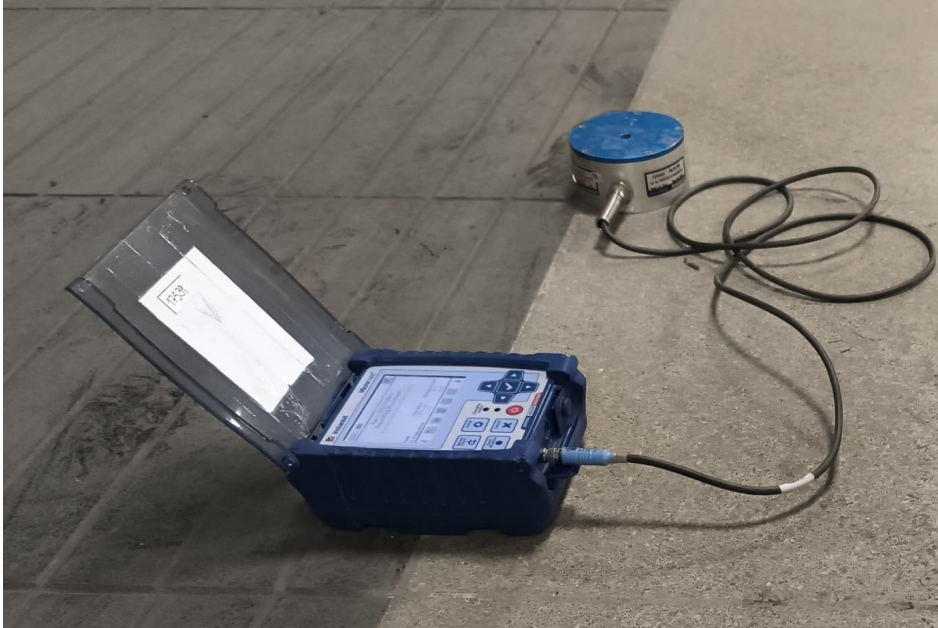
Micromate Unit Monitoring Vibrations

The Micromate monitoring unit can store up to 1,000 events, and when utilizing Vision II software, data is automatically uploaded and ready for analysis.

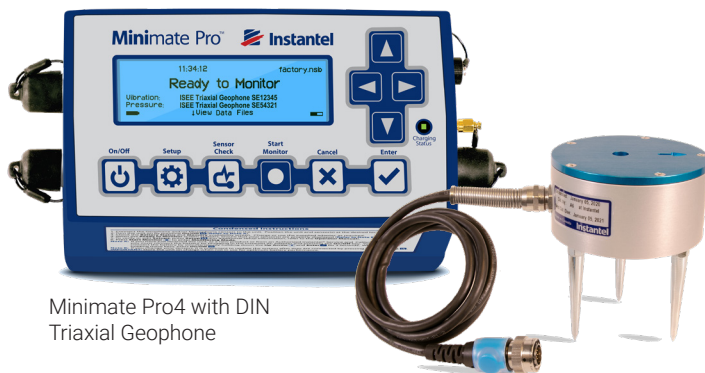
Minimate Pro4 with DIN Triaxial Geophone

The Minimate Pro4 offers a robust design and advanced analysis when utilizing THOR Advanced software. With the Minimate Pro4 and THOR Advanced, the structural

response can be calculated based on a comparison of two waveforms recorded simultaneously inside and outside a structure.

Both triaxial geophones are calibrated to the international DIN standard with a frequency range of 1 to 315 Hz or 1 to 80 Hz for the Minimate Pro unit and 1 to 315 Hz for the Micromate unit.

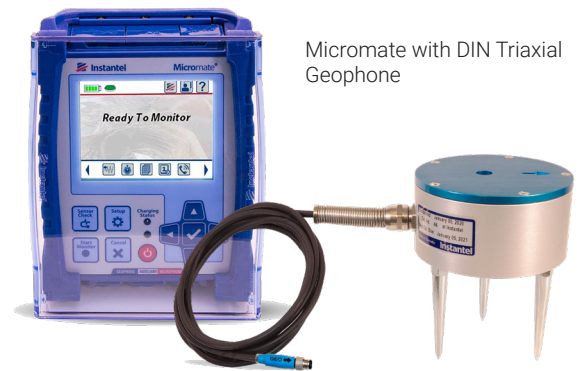
Micromate with DIN Triaxial Geophone

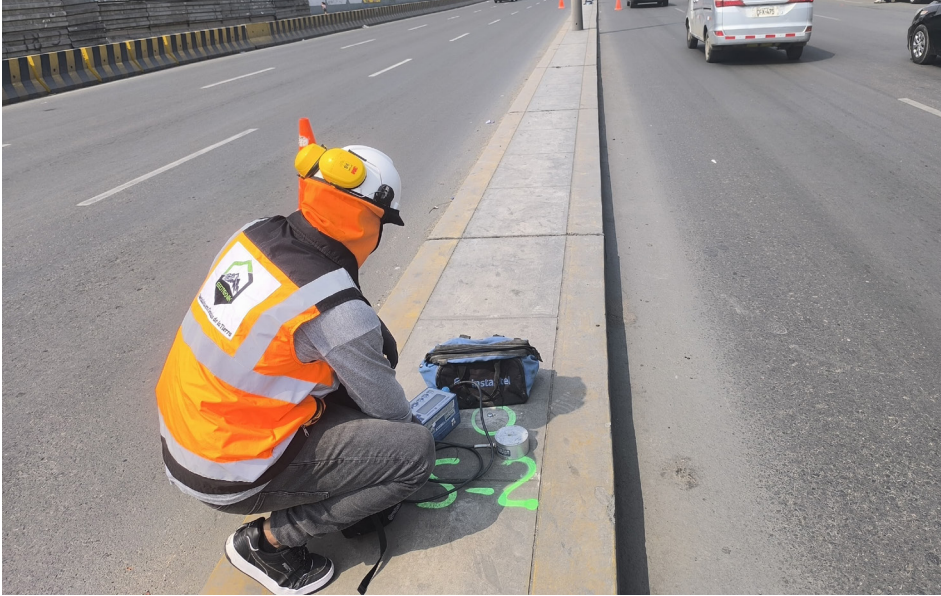
Setting up the Minimate Pro4

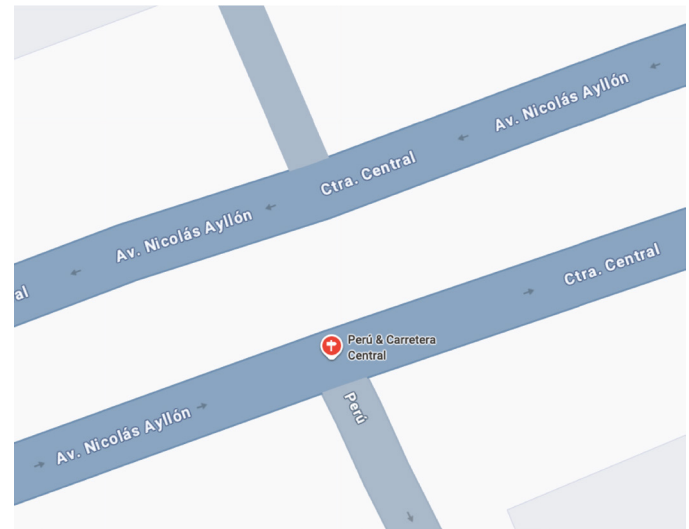
Monitoring Location - Study Point 2

Utilizing a combination of both Micromate and Minimate Pro units with DIN triaxial geophones, continuous measurements were taken during two time slots (12:45–16:16 and 18:15–21:30), using sensors strategically placed on the surface and in the concourse. The equipment was configured to capture three-dimensional data aligned with the traffic flow on Nicolás Ayllón Avenue. Measurements included the vertical, longitudinal, and transverse axes, as well as calculations of the vector sum and dominant frequencies.
