# CASE STUDIES

# Case Study: Structural Vibration Monitoring for Slovenia's National Transport Infrastructure Project

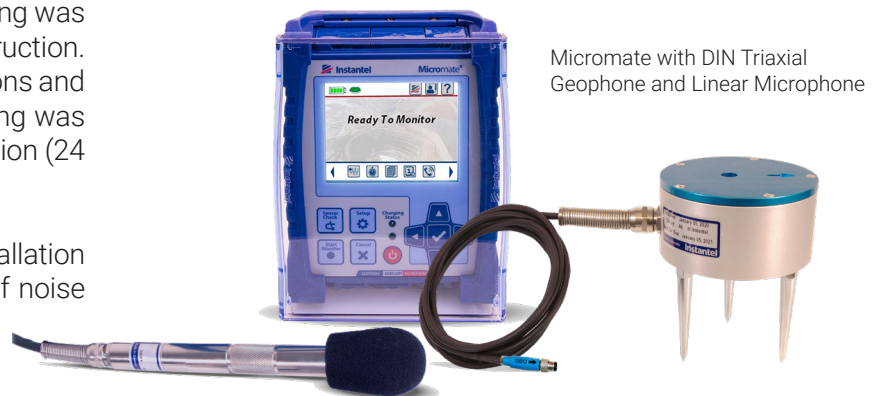
Utilizing the Micromate unit, DIN triaxial geophones, and linear microphones monitoring campaigns were carried out to measure vibration velocities during preparatory earthworks such as transport and compaction for the preparation of access roads, as well as during dynamic pile load tests for the foundations of the Škale viaduct.

Section H (Konovo) required long-term continuous monitoring (24 hours per day) with online supervision during tunnel excavation works.

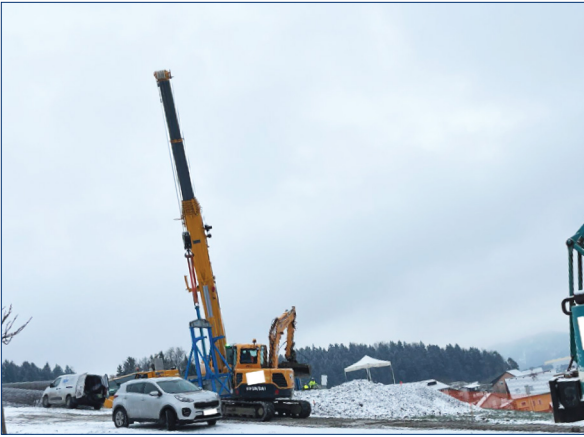
Section C: Pile Testing Škale Viaduct

In Section C (Figure 2 - Map) in Škale, monitoring was carried out during periods of intensive construction. During the drilling of piles for viaduct foundations and during dynamic load testing of piles, monitoring was carried out continuously with an online connection (24 hours per day for two weeks).

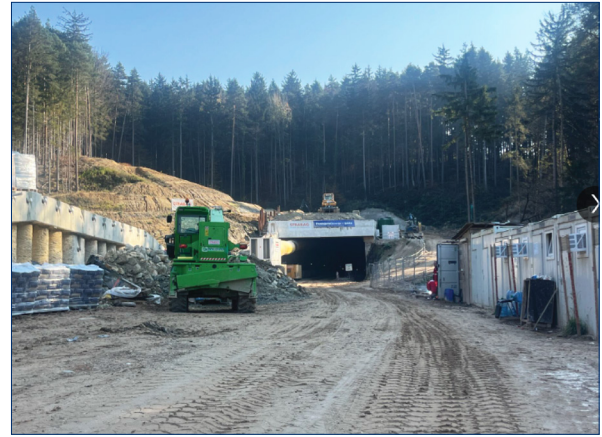
Section H: Konovo Tunnel

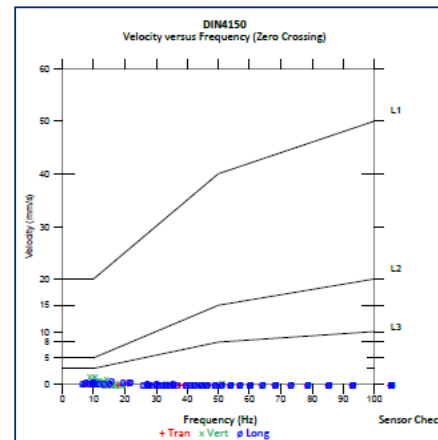
Geophone	Tran	Vert	Long
Peak Particle Velocity	0.560 mm/s	1.553 mm/s	0.725 mm/s
Zero Crossing Frequency	12.3 Hz	10.6 Hz	15.8 Hz
Time (Relative to Trigger)	0.018 sec	0.243 sec	0.011 sec
Peak Acceleration	0.010 g	0.015 g	0.012 g
Peak Displacement	0.006 mm	0.022 mm	0.006 mm
Sensor Check	✓ Passed	✓ Passed	✓ Passed
Frequency	7.3 Hz	7.5 Hz	7.1 Hz
Overswing Ratio	3.1	3.4	3.9
Peak Vector Sum	1.556 mm/s at 0.243 sec
